# Tantalum Materials in the CPI for the Next Millennium

#### ABSTRACT

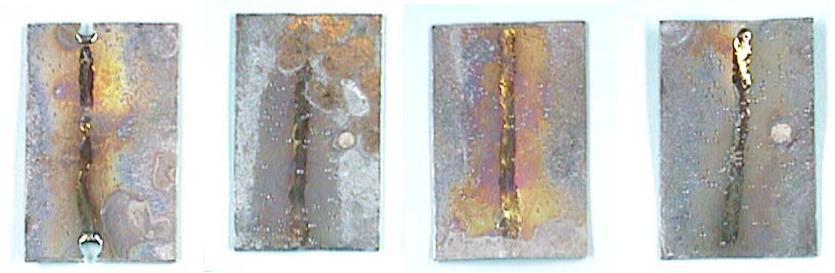
A visual evaluation of the samples tested in 5% NaOH showed pitting type attack that was heaviest away from the weld and HAZ, Figure 1. For the Ta sample, there was also a translucent white deposit in the pits. For the Ta and TaW samples, the pits were deeper than on the Ta/Pt and TaW/Pt samples. There were also areas of heavy, non-uniform attack where Teflon spacers were placed between the samples. Approximately 75% of the platinum spots were still visible on the Ta/Pt and TaW/Pt samples.

FIGURE 1 – 5% NaOH at 100°C, Ta, Ta/Pt, TaW, and TaW/Pt samples, respectively.

For the 5% NaOH solution, the corrosion rate on all the samples similar. While platinum spotting marginally improved the corrosion resistance of tantalum and Ta-2.5W alloy, higher hydrogen enrichment (and embrittlement) was greatly reduced. For the 10% NaOH solutions, the corrosion rate on the TaW and TaW/Pt samples was greater than on the Ta and Ta/Pt samples. Platinum spotting did not significantly improve the corrosion resistance for either tantalum or the Ta-2.5W alloy. This increased corrosive attack also produces significantly higher hydrogen enrichment (and embrittlement) in the TaW and TaW/Pt samples. As will be seen later in this paper, platinum spotting almost always improves the corrosion resistance of both the pure tantalum and the Ta-2.5W alloy. However, this is not the case when pure tantalum and the Ta-2.5W alloy are exposed to NaOH.

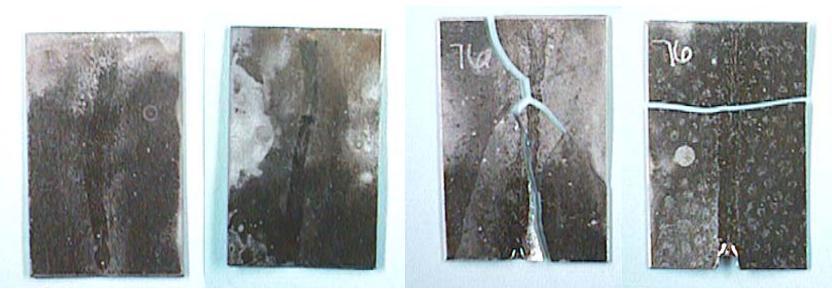
All the samples tested in the 10% NaOH at 66°C showed general uniform corrosive attack and slightly greater attack where the Teflon spacers were in contact with the sample, Figure 3. Also, the TaW and TaW/Pt samples showed greater attack than the Ta and Ta/Pt samples, respectively. Both the TaW and TaW/Pt samples cracked during cleaning. On the Ta/Pt and TaW/Pt samples, the platinum spots were completely removed. The results for the samples tested in the 10% NaOH at 100°C were exactly the same as described above, Figure 4, although the general uniform corrosive attack was heavier than on the samples tested at 66°C. There was also some pitting of the Ta and Ta/Pt samples were the Teflon spacers were in contact with the samples.

FIGURE 3 – 10% NaOH at 66°C, Ta, Ta/Pt, TaW, and TaW/Pt samples, respectively.

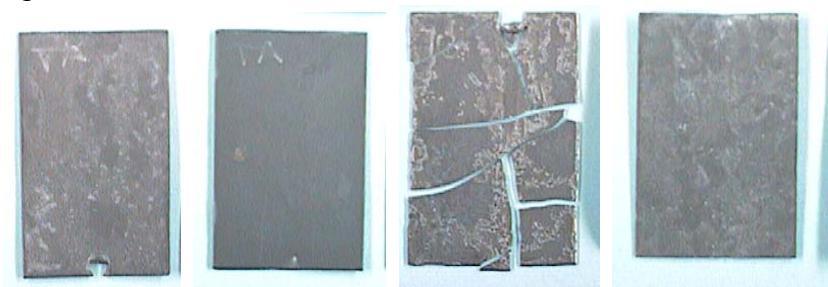
FIGURE 4 – 10% NaOH at 100°C, Ta, Ta/Pt, TaW, and TaW/Pt samples, respectively.

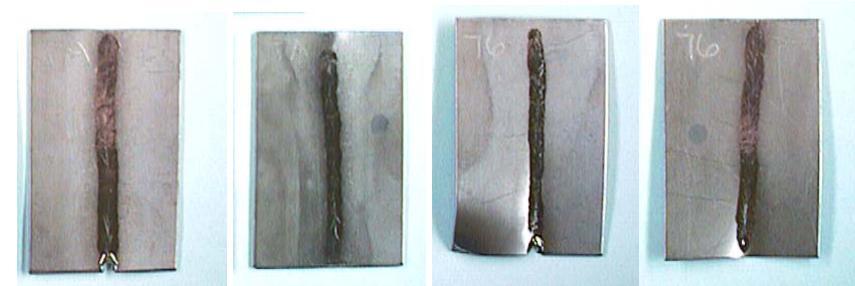
All the samples tested in the 18% HCl + 200 ppm Cu at 220°C showed no visible signs of corrosive attack except for some very light etching on the Ta/Pt sample, Figure 5. On the Ta/Pt and TaW/Pt samples, the platinum spots were completely removed. Hydrogen enrichment was almost non-existent in all the samples.

FIGURE 5 – 18% HCl + 18 ppm Cu at 220°C, Ta, Ta/Pt, TaW, and TaW/Pt samples, respectively.

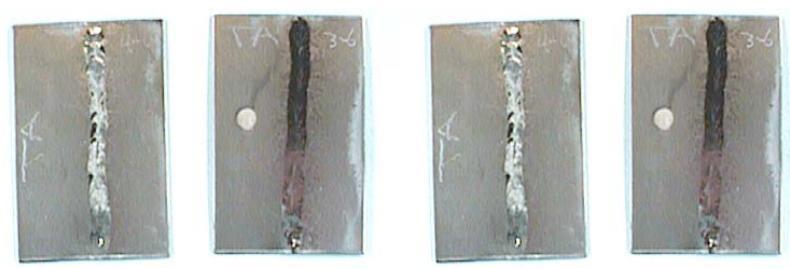
All the samples tested in the 30% HCl at 200°C showed some very light general uniform corrosive attack, Figure 6. Surprisingly, the TaW and TaW/Pt samples showed slightly greater corrosion rates than the Ta and Ta/Pt samples, respectively. On the Ta/Pt and TaW/Pt samples, approximately 85% and 65% of the platinum spots were still visible, respectively. Hydrogen enrichment was almost none existent in all the samples.

FIGURE 6 – 30% HCl at 200°C, Ta, Ta/Pt, TaW, and TaW/Pt samples, respectively.

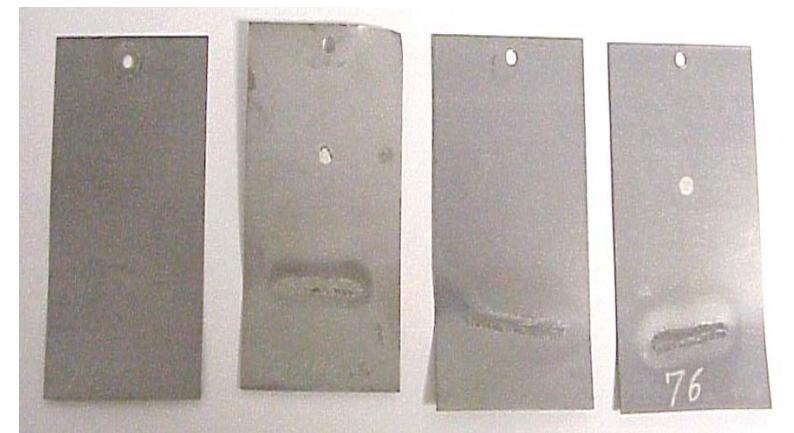
FIGURE 7 – 96% H<sub>2</sub>SO<sub>4</sub> at 230°C, Ta, Ta/Pt, TaW, and TaW/Pt samples, respectively.

A visual evaluation of the samples tested in  $H_2SO_4$  acid showed little evidence of chemical attack with the exception of some light etching of the weld and weld HAZ, Figures 7 to 10. However, the platinum spots were completely dissolved/removed from the Ta/Pt and TaW/Pt samples after eight weeks of testing although there was evidence the spot had been present on the samples at the start of the corrosion test. After eight weeks of exposure, all test specimens, except the Ta/Pt specimens in 97.9% acid, were coated with a loosely adherent layer of white deposits. The four Ta/Pt spot specimens exposed to the 97.9% acid did not contain any whites deposits. Instead, they were coated with a very thin, tightly adherent, light brown colored film.

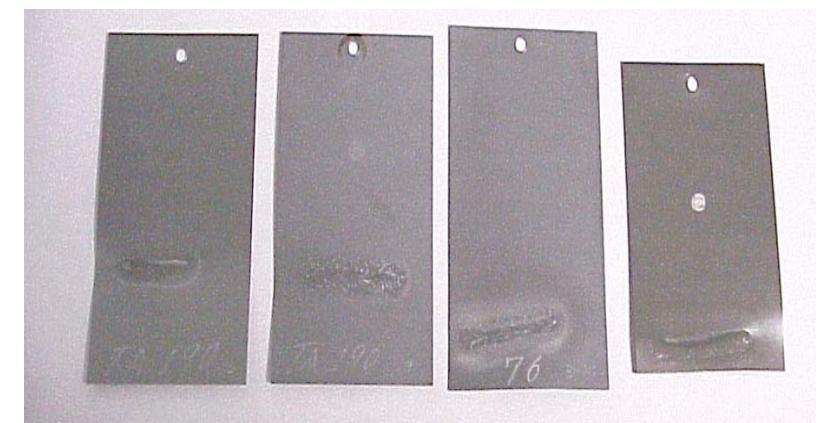
FIGURE 8 – 97% H<sub>2</sub>SO<sub>4</sub> at 230°C, Ta, Ta/Pt, TaW, and TaW/Pt samples, respectively.

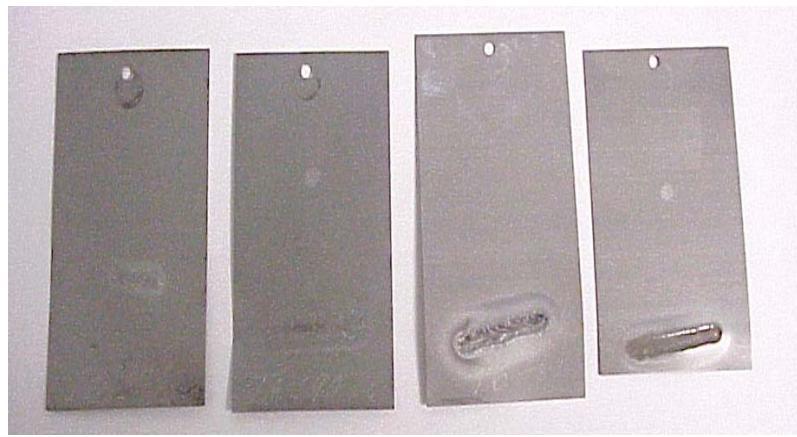
FIGURE 9 – 97.5% H<sub>2</sub>SO<sub>4</sub> at 230°C, Ta, Ta/Pt, TaW, and TaW/Pt samples, respectively.

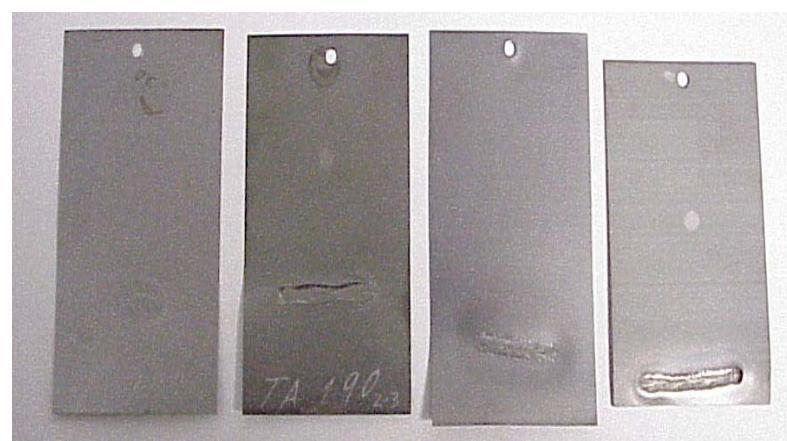
FIGURE 10 – 97.9% H<sub>2</sub>SO<sub>4</sub> at 230°C, Ta, Ta/Pt, TaW, and TaW/Pt samples, respectively.

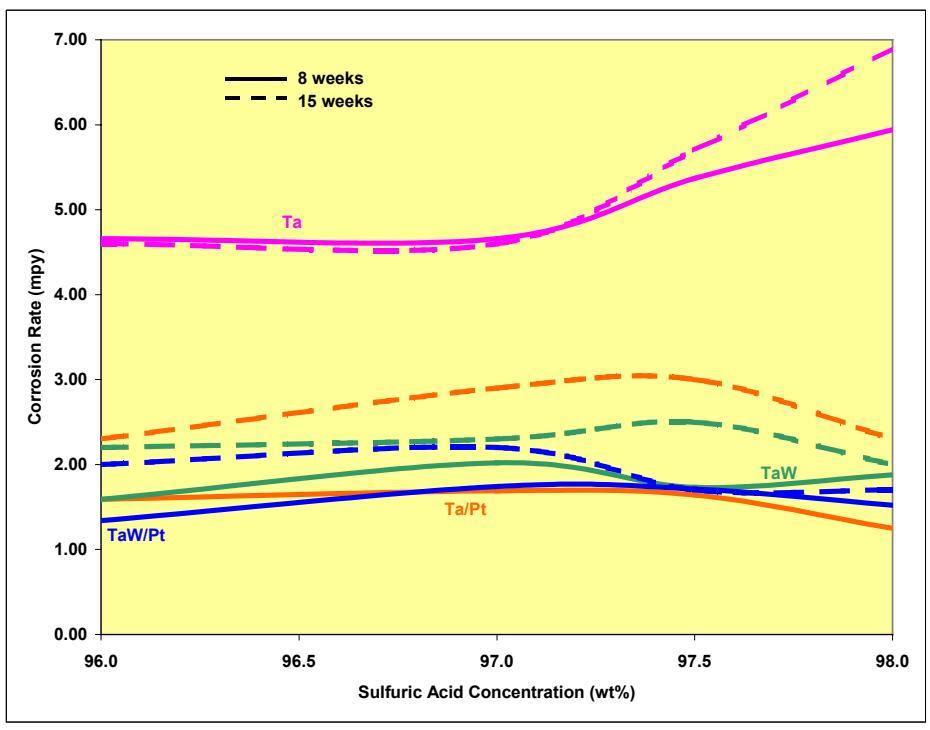
Figure 11 shows corrosion rate results for in  $H_2SO_4$  acid. These results suggest that while platinum spotting improves the corrosion resistance of pure tantalum to  $H_2SO_4$  acid, this effect can diminish over time as the platinum spot is dissolved. In the short term, platinum spotting of tantalum produces corrosion rates comparable to the Ta-2.5W alloy. For the Ta-2.5W alloy, platinum spotting also improves corrosion resistance to  $H_2SO_4$  acid; however, this effect is not as pronounced as with pure tantalum; however, when working with a tube wall thickness around .015" any improvement is significant in the overall life of the tubing. Many of the existing thermo-wells in CPI service are fabricated from pure tantalum, which would benefit from the addition of platinum spots to improve their service life. Asahi Chemicals has shown how pure tantalum instrumentation equipment which had been

FIGURE 11 - Corrosion Rates in H<sub>2</sub>SO<sub>4</sub> Acid
